**Test Report No. 9-1531-R2B**

**EVALUATION OF LOWER AND UPPER RAIL ELEMENTS WITH  
MIDWEST GUARDRAIL SYSTEM TO ADDRESS MOTORCYCLE  
SAFETY**

Sponsored by the  
**Motorcycle Safety Pooled Fund**  
and the  
**Texas Department of Transportation**

**TEXAS A&M TRANSPORTATION INSTITUTE PROVING GROUND**

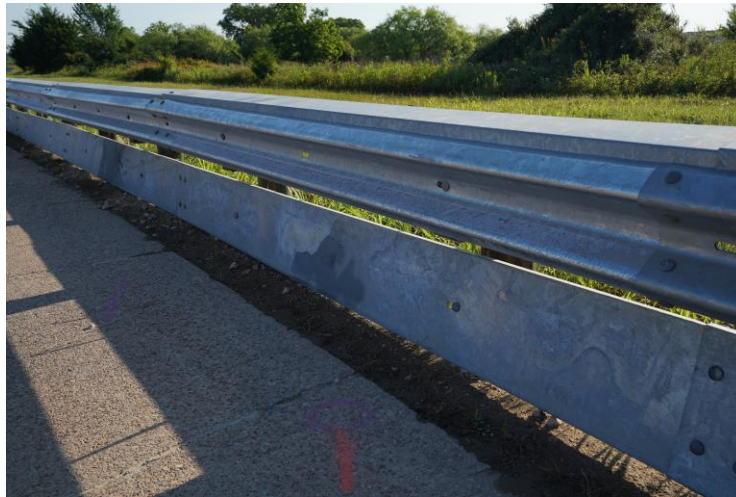
A guardrail system with lower and upper rail elements was previously developed to address motorcycle safety (2). The system consisted of a MGS with round wood posts, steel rub rail, and steel cap rail. Figure 1.1 shows the system prior to testing.

**Figure 1.1. Wood Post MGS with Motorcycle Rail Elements. (2)**

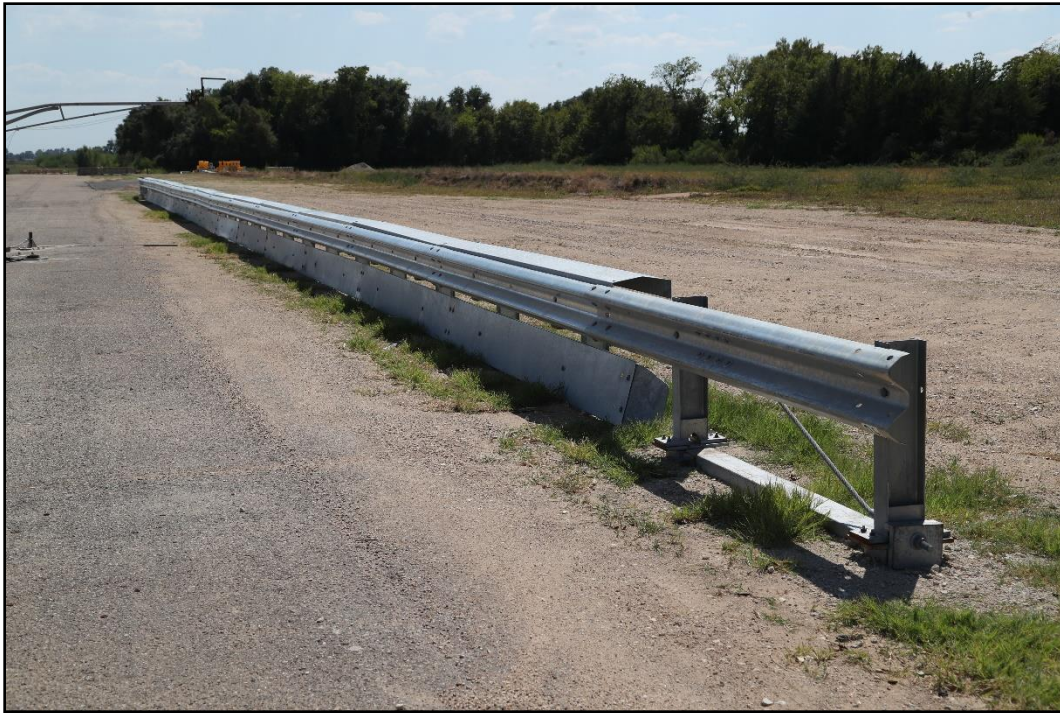
**Figure 2.2. Overall View of the Enhanced Motorcycle MGS prior to Testing.**

Figure 2.1 presents the overall information on the Enhanced Motorcycle MGS, and Figure 2.2 through Figure 2.7 provide photographs of the installation. Appendix A provides further details on the Enhanced Motorcycle MGS. Drawings were provided by the Texas A&M Transportation Institute (TTI) Proving Ground, and construction was performed by TTI Proving Ground personnel and DMA Contractors.

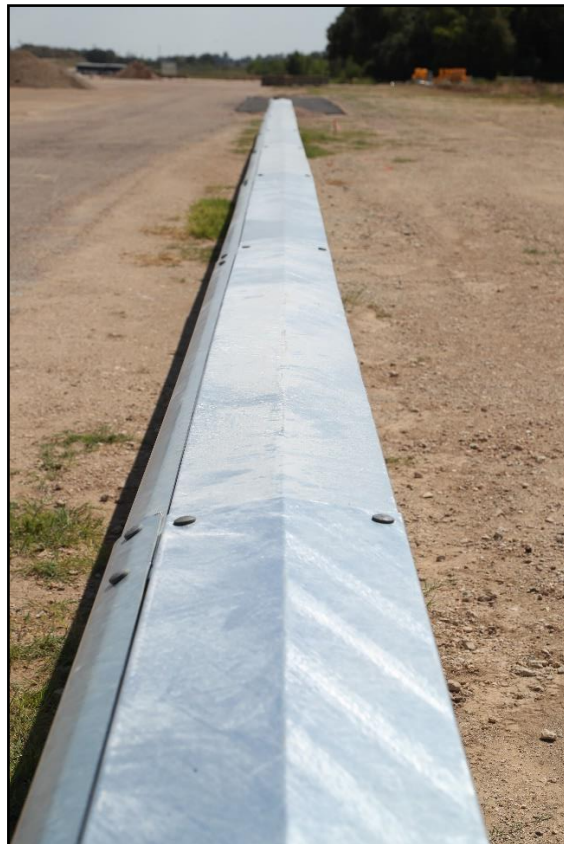
**Figure 2.3. Upstream In-Line View of the Enhanced Motorcycle MGS prior to Testing.**

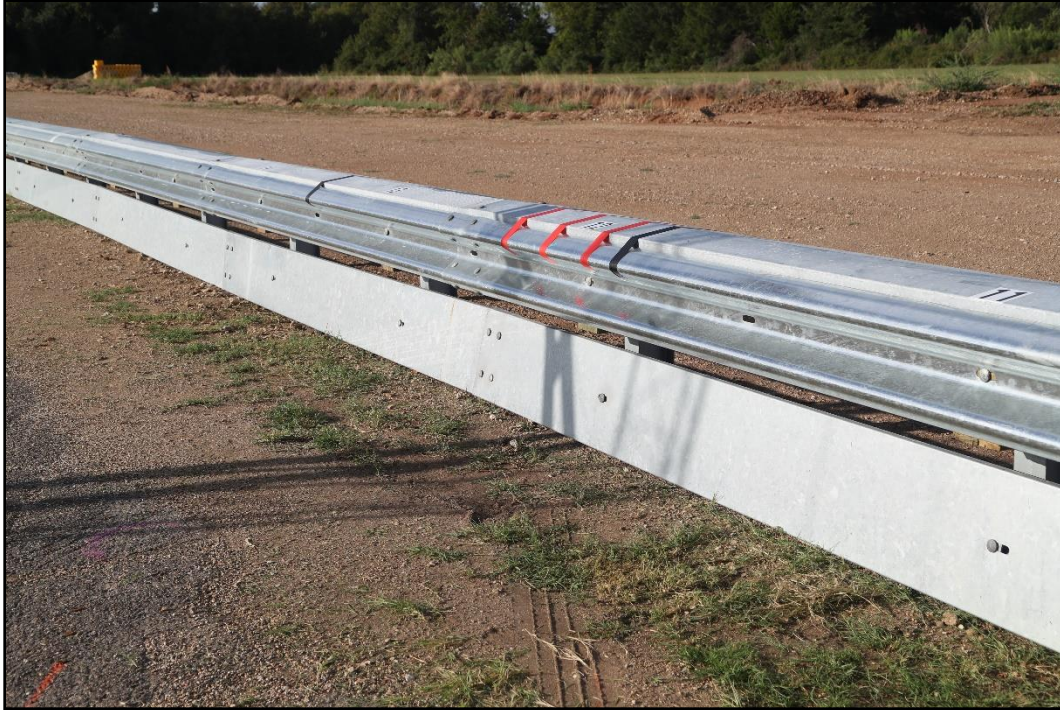
**Figure 2.4. Enhanced Motorcycle MGS at Impact prior to Testing.**

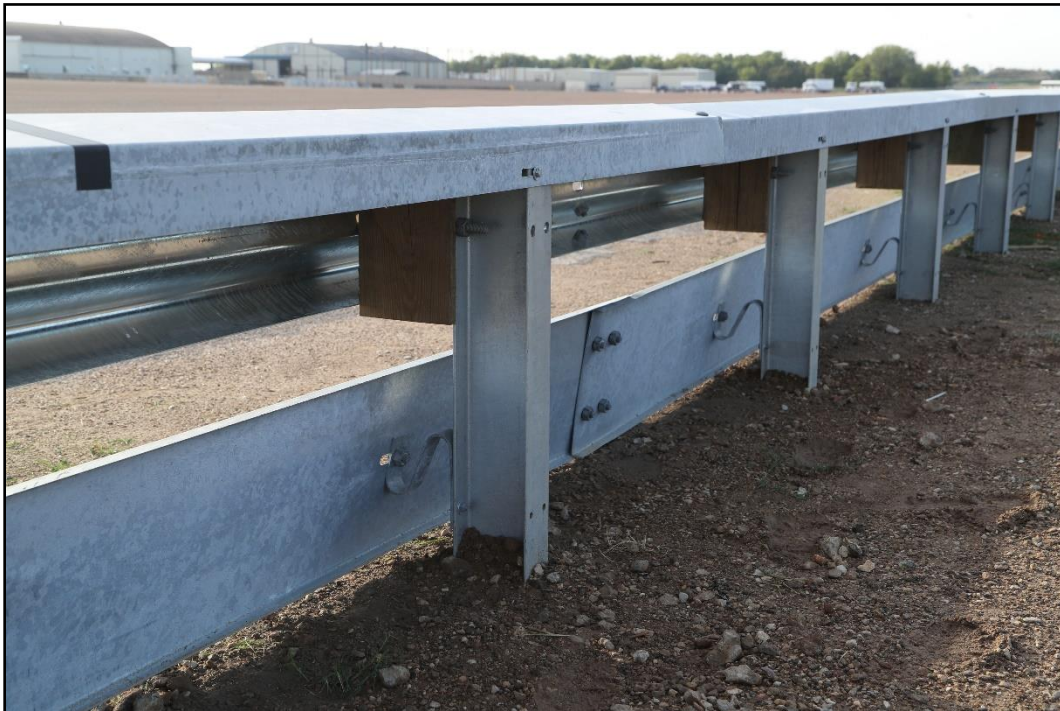
**Figure 2.5. Oblique Field-Side View of Enhanced Motorcycle MGS prior to Testing.**

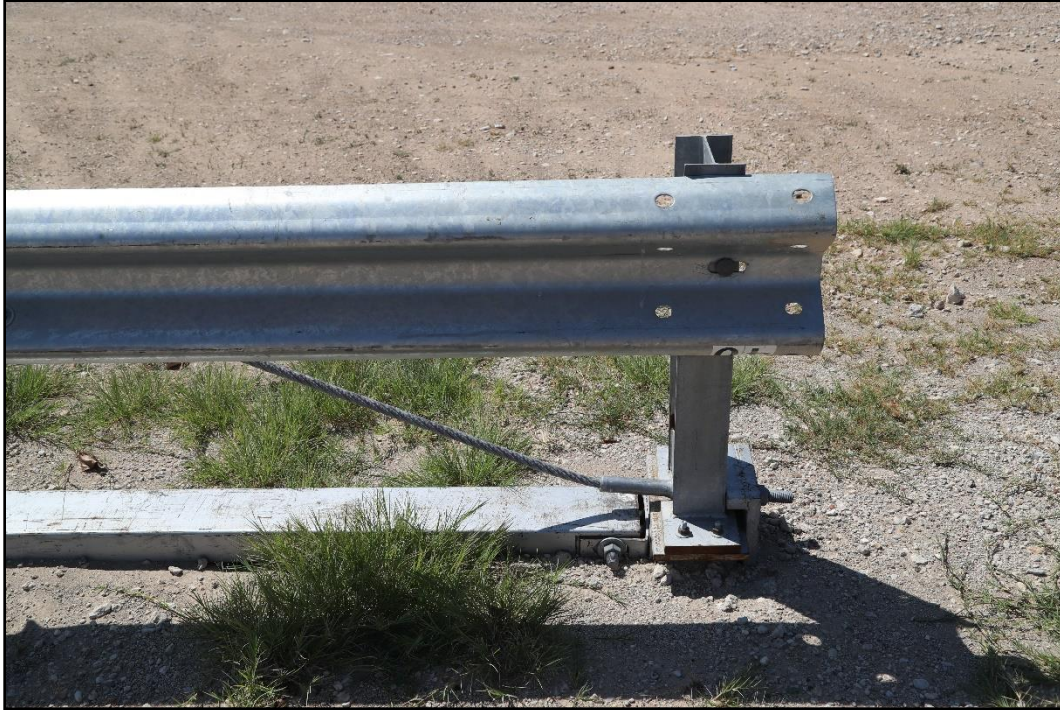
**Figure 2.6. Focus on Post 1 without Rub Rail of the Enhanced Motorcycle MGS prior to Testing.**

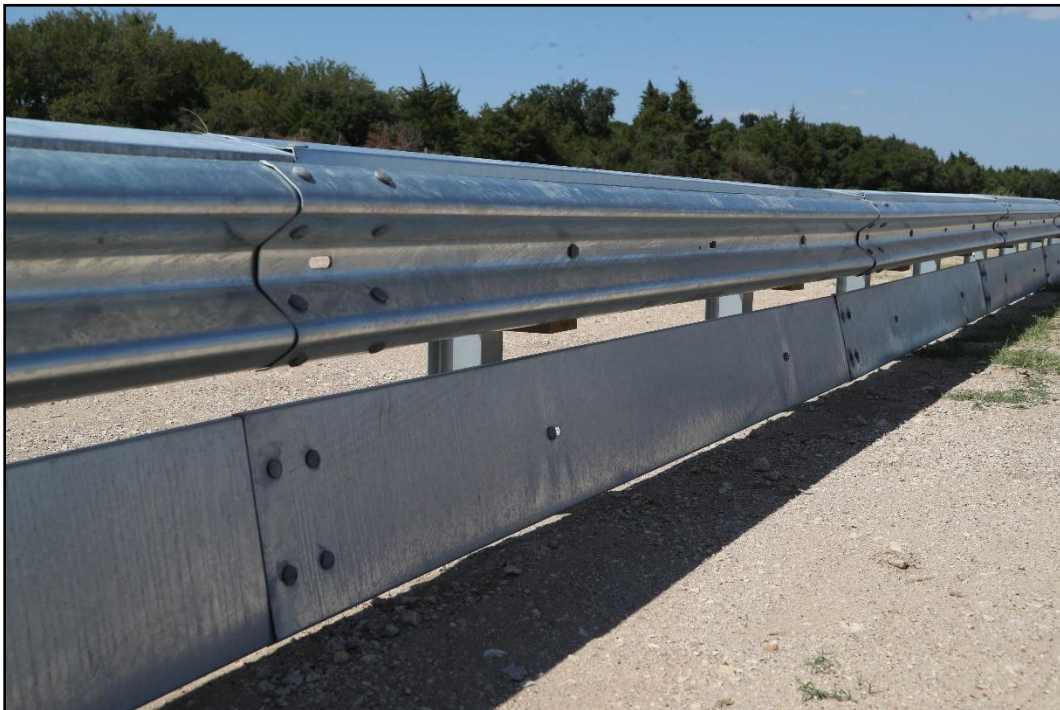
**Figure 2.7. Oblique Upstream View of Enhanced Motorcycle MGS prior to Testing.**

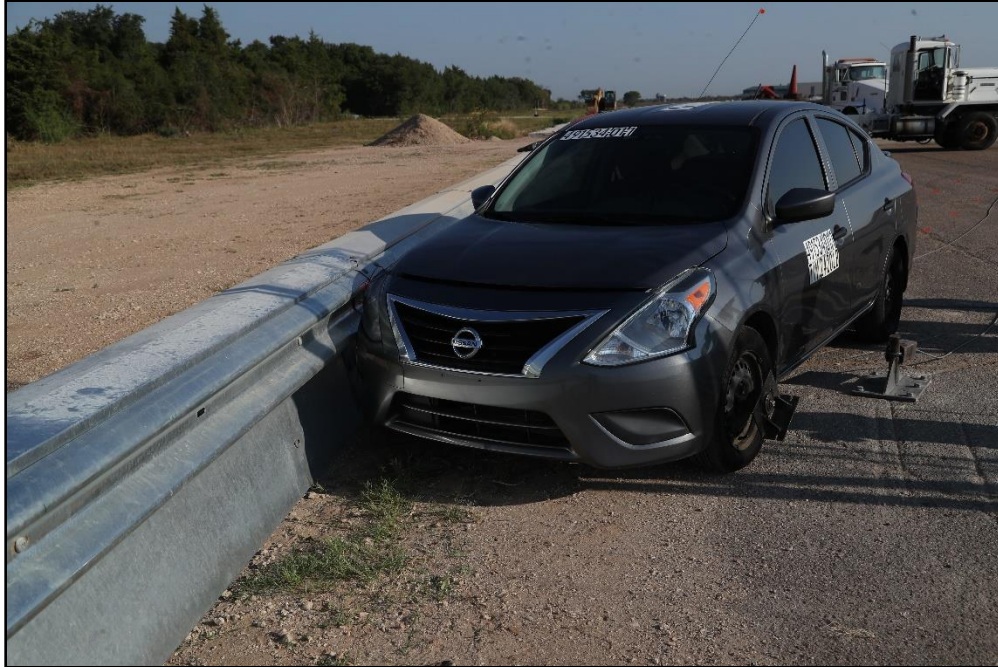
**Figure 5.1. Enhanced Motorcycle MGS/Test Vehicle Geometrics for Test 491534-01-1.**

See Table 5.1 for the *MASH* impact conditions and Table 5.2 for the exit parameters for Test 491534-01-1. Figure 5.1 and Figure 5.2 depict the target impact setup.

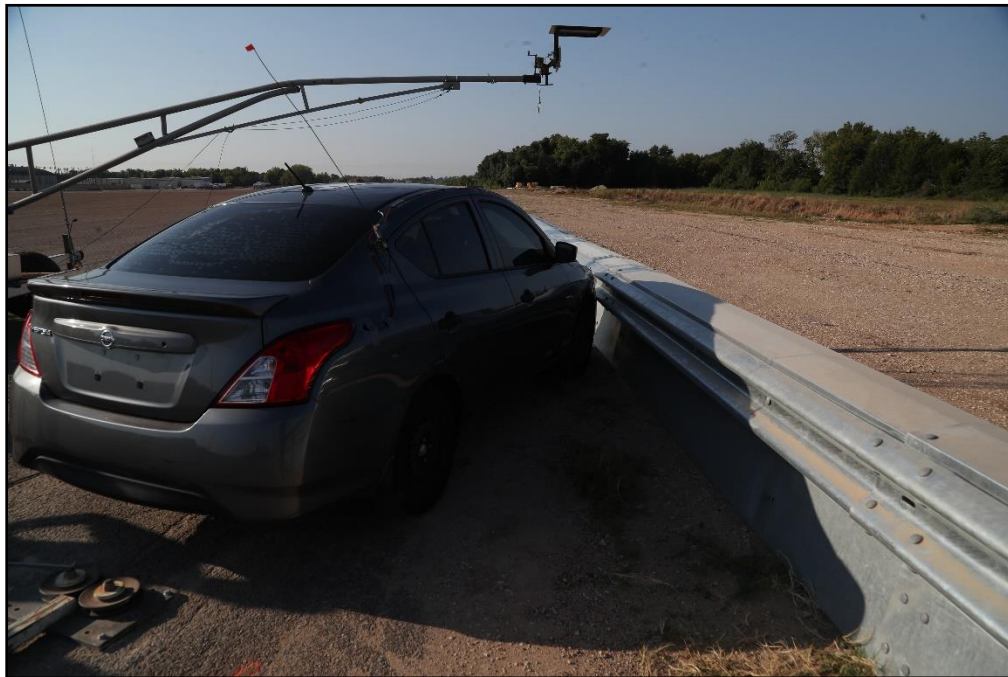
**Figure 5.2. Enhanced Motorcycle MGS/Test Vehicle Impact Location for Test 491534-01-1.**

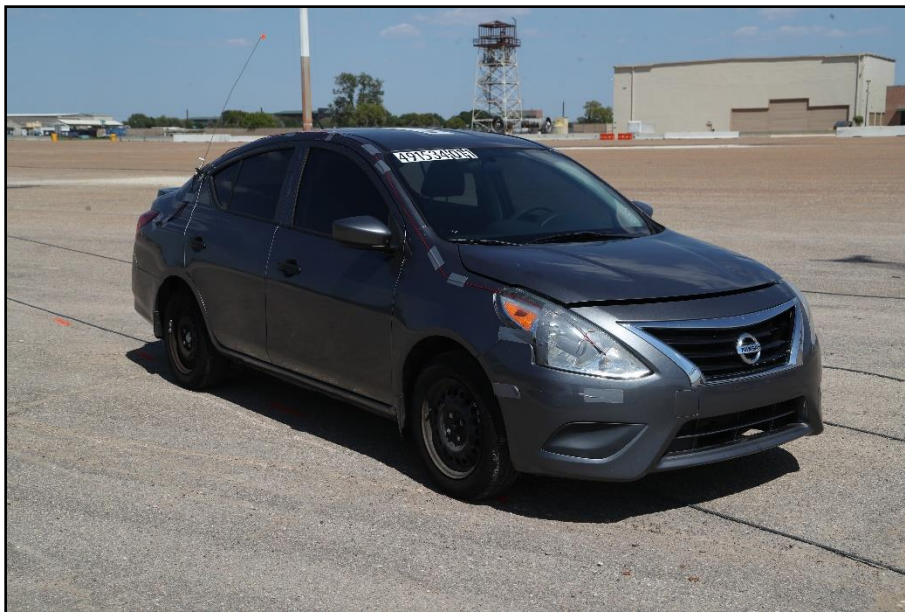
**Figure 5.3. Impact Side of Test Vehicle before Test 491534-01-1.**

Figure 5.3 and Figure 5.4 show the 2018 Nissan Versa used for the crash test. Table 5.4 shows the vehicle measurements. Figure C.1 in Appendix C.1 gives additional dimensions and information on the vehicle.

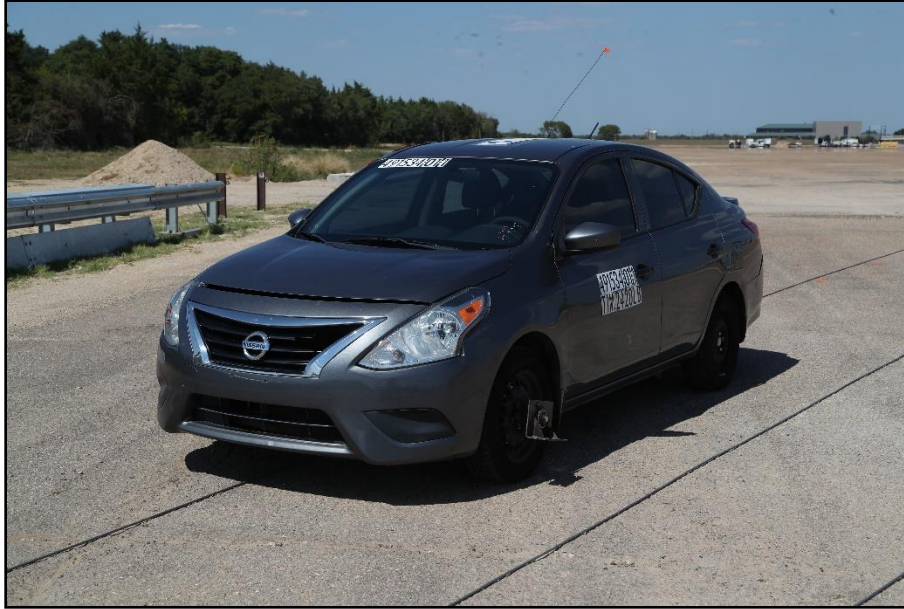
**Figure 5.4. Opposite Impact Side of Test Vehicle before Test 491534-01-1.**

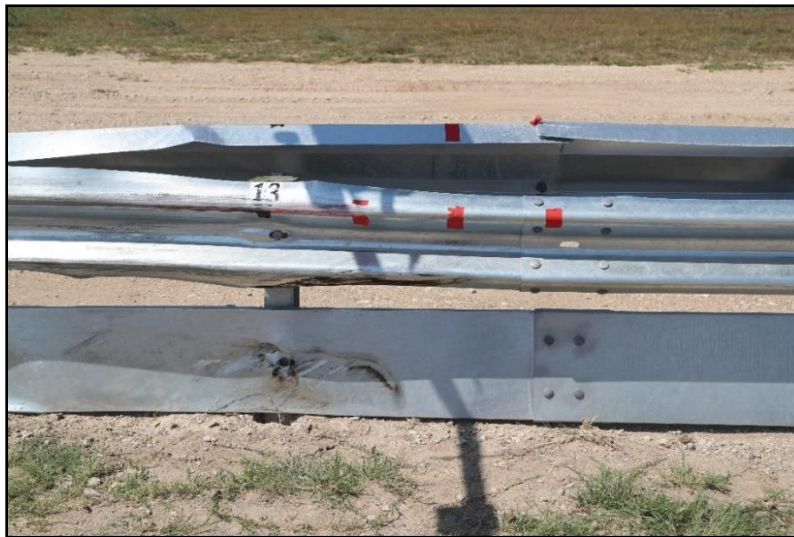
**Figure 5.5. Enhanced Motorcycle MGS at Impact Location after Test 491534-01-1.**

Table 5.6 describes the damage to the Enhanced Motorcycle MGS. Table 5.7 describes the deflection and working width of the Enhanced Motorcycle MGS. Figure 5.5 and Figure 5.6 show the damage to the Enhanced Motorcycle MGS.

Test Parameter	Measured
Permanent Deflection/Location	9.8 inches toward field side, 20 inches upstream of post 14
Dynamic Deflection	13.8 inches toward field side, top cover between posts 12 and 13
Working Width <sup>a</sup> and Height	33.5 inches, at a height of 38.8 inches

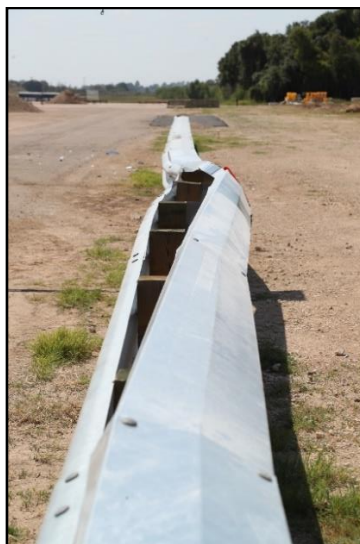
**Figure 5.6. Downstream View of Enhanced Motorcycle MGS after Test 491534-01-1.**

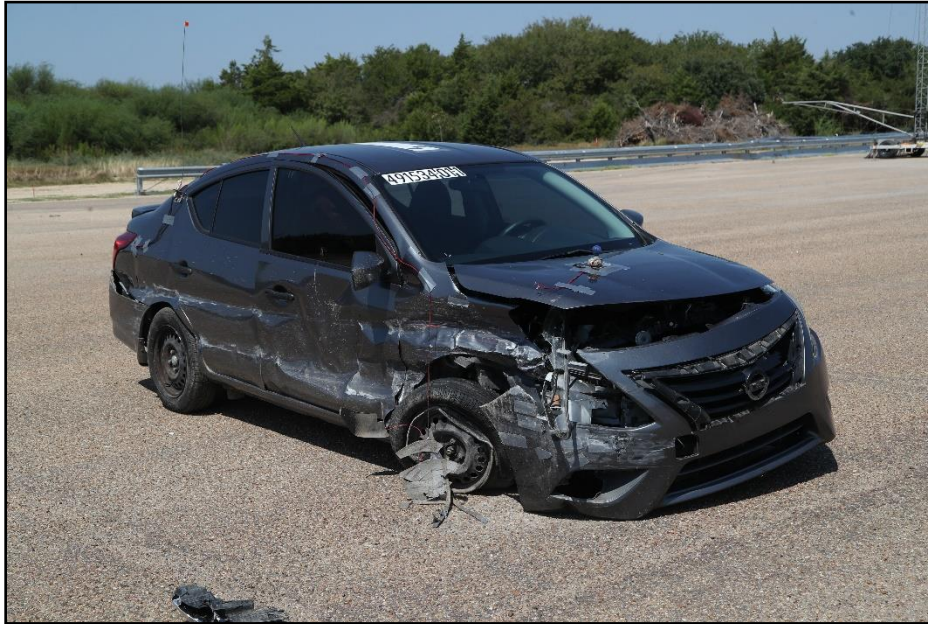
**Figure 5.7. Impact Side of Test Vehicle after Test 491534-01-1.**

Figure 5.7 and Figure 5.8 show the damage sustained by the vehicle. Figure 5.9 and Figure 5.10 show the interior of the test vehicle. Table 5.8 and Table 5.9 provide details on the occupant compartment deformation and exterior vehicle damage. Figures C.2 and C.3 in Appendix C.1 provide exterior crush and occupant compartment measurements.

<b>Side Windows</b>	Side windows remained intact
<b>Maximum Exterior Deformation</b>	10 inches above the front bumper
<b>VDS</b>	01RFQ4
<b>CDC</b>	01FREW6
<b>Fuel Tank Damage</b>	None
<b>Description of Damage to Vehicle:</b>	The bumper, grill, radiator, and support were dented. The right front headlight was busted. The right front frame rail and the right front wheel were bent, with the right front tire being flat. The whole passenger side of the vehicle was dented and scratched. There was a 3-inch gap at the top of the right front door. The right rear bumper was scratched up.

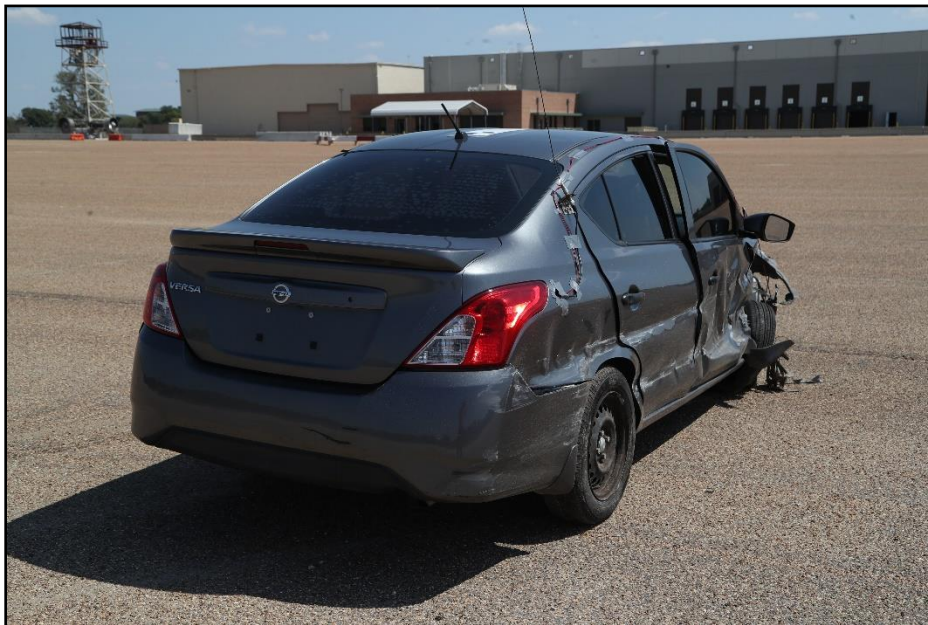
**Figure 5.8. Rear Impact Side of Test Vehicle after Test 491534-01-1.**

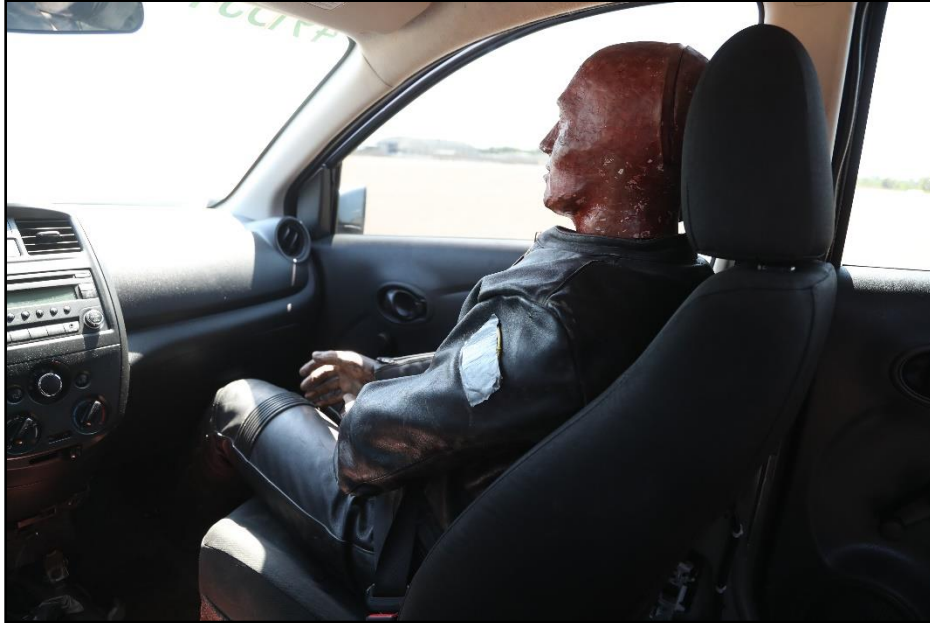
**Figure 5.9. Overall Interior of Test Vehicle after Test 491534-01-1.**

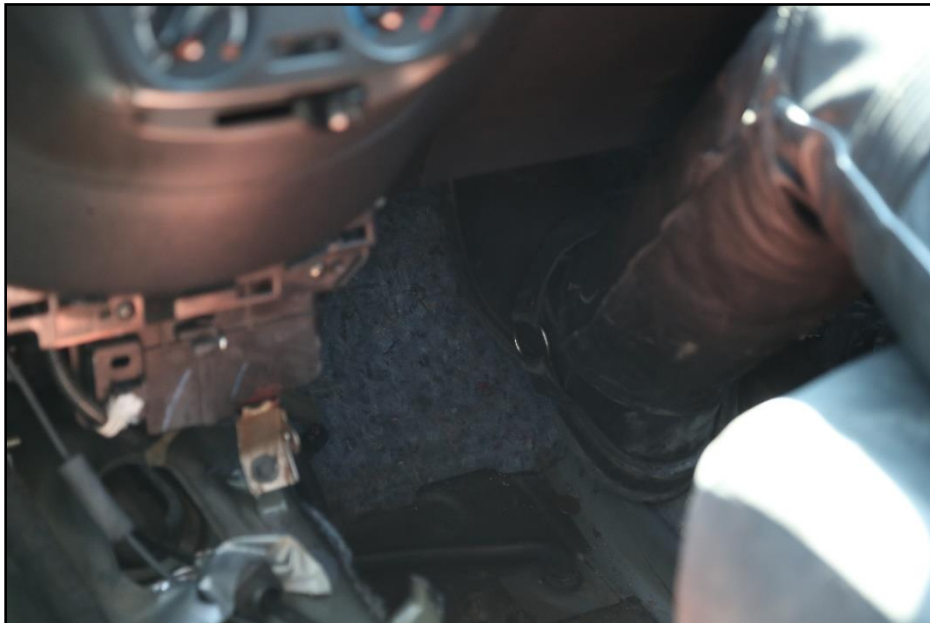
**Figure 5.10. Interior of Test Vehicle on Impact Side after Test 491534-01-1.**

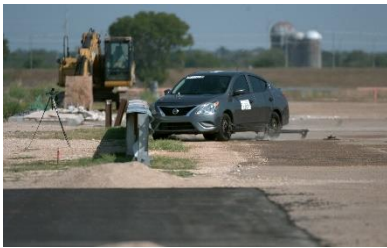
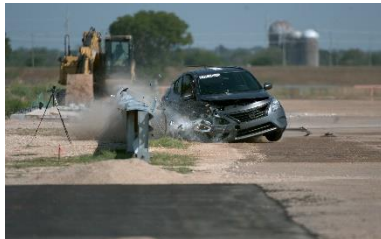
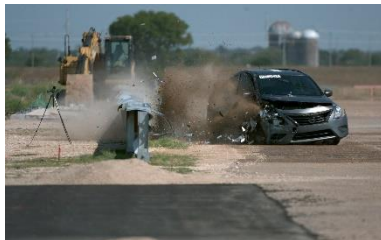
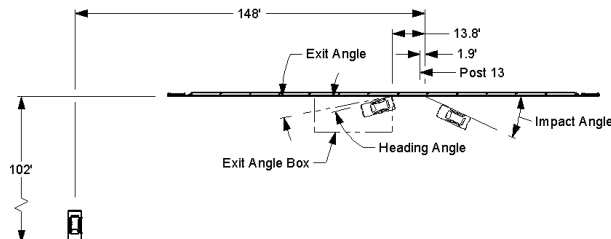
<b>0.000 s</b>	Test Agency	Texas A&M Transportation Institute (TTI)					
	Test Standard/Test No.	MASH 2016, Test 3-10					
	TTI Project No.	491534-01-1					
	Test Date	2023-09-19

<b>0.200 s</b>	<b>TEST ARTICLE</b>						
	Type	Longitudinal barriers					
	Name	Enhanced Motorcycle MGS					
	Length	181 ft 3 inches

<b>0.400 s</b>	Key Materials	Galvanized steel posts and rails, timber wood blockouts					
	Soil Type and Condition	AASHTO M147-65(2004), Type 1, Grade D crushed concrete					
	<b>TEST VEHICLE</b>						
	Type/Designation	1100C

<b>0.600 s</b>	Year, Make and Model	2018 Nissan Versa					
	Inertial Weight (lb)	2443					
	Dummy (lb)	165					
	Gross Static (lb)	2608					
<b>IMPACT CONDITIONS</b>							
Impact Speed (mi/h)	61.2						
Impact Angle (deg)	25.4						
Impact Location	23.1 inches upstream of centerline of post 13						
Impact Severity (kip-ft)	56.3						
<b>EXIT CONDITIONS</b>

Exit Speed (mi/h)	43.1						
Trajectory/Heading Angle (deg)	14.9/11.4						
Exit Box Criteria	Vehicle met the exit box criteria						
Stopping Distance	148 ft downstream 102 ft to the traffic side						
<b>TEST ARTICLE DEFLECTIONS</b>							
Dynamic (inches)	13.8						
Permanent (inches)	9.8 inches						
Working Width/Height (inches)	33.5/38.8						
<b>VEHICLE DAMAGE</b>							
VDS	01RFQ4						
CDC	01FREW6						
Max. Ext. Deformation (inches)	10						
Max Occupant Compartment Deformation	0.5 inch into the floor pan						
<b>OCCUPANT RISK VALUES</b>							
Long. OIV (ft/s)	19.4	Long. Ridedown (g)	9.7	Max 50-ms Long. (g)	-8.8	Max Roll (deg)	18.5
Lat. OIV (ft/s)	23.3	Lat. Ridedown (g)	13.6	Max 50-ms Lat. (g)	-9.6	Max Pitch (deg)	3.7
THIV (m/s)	9.1	ASI	1.3	Max 50-ms Vert. (g)	-2.3	Max Yaw (deg)	67.8

**Figure 5.11. Summary of Results for MASH Test 3-10 on Enhanced Motorcycle MGS.**

Figure 5.11 summarizes the results of *MASH* Test 491534-01-1.

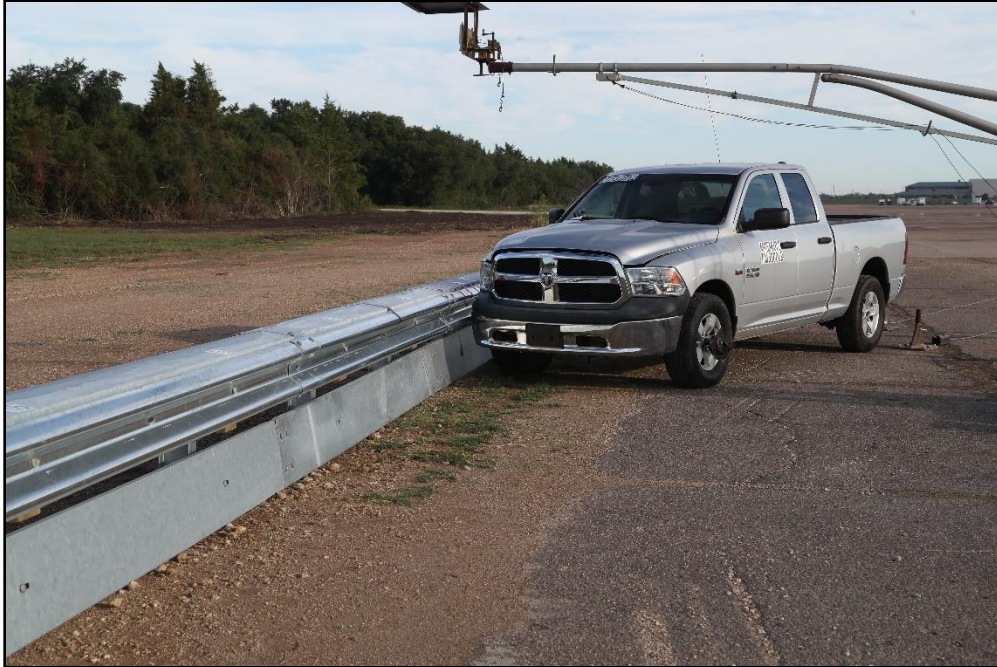
**Figure 6.1. Enhanced Motorcycle MGS/Test Vehicle Geometrics for Test 491534-01-2.**

See Table 6.1 for the impact conditions and Table 6.2 for the exit parameters for Test 491534-01-2. Figure 6.1 and Figure 6.2 depict the target impact setup.

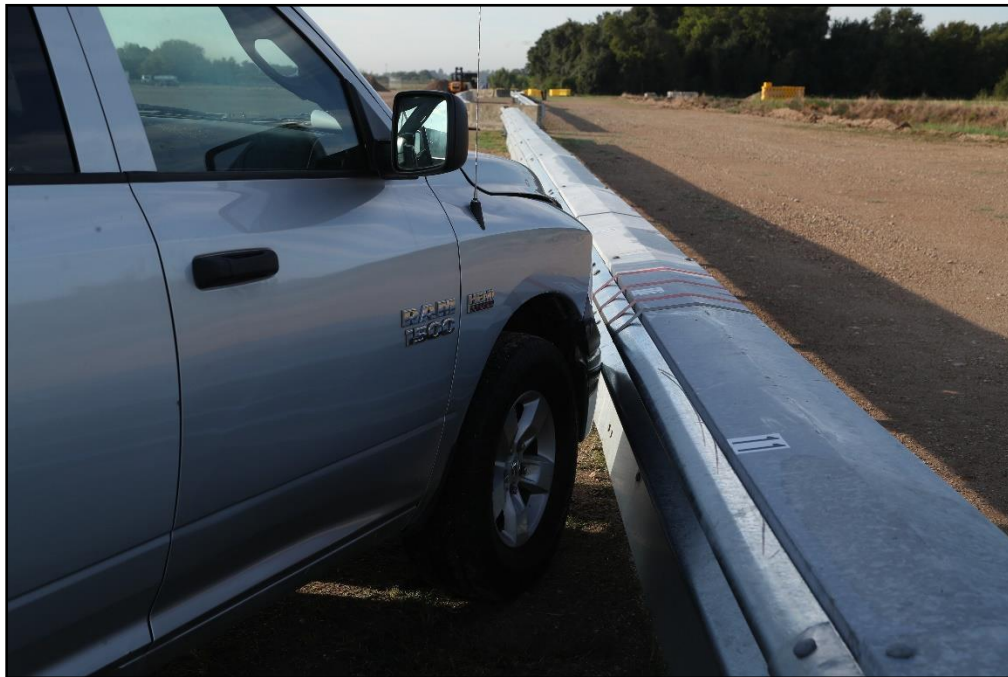
**Figure 6.2. Enhanced Motorcycle MGS/Test Vehicle Impact Location for Test 491534-01-2.**

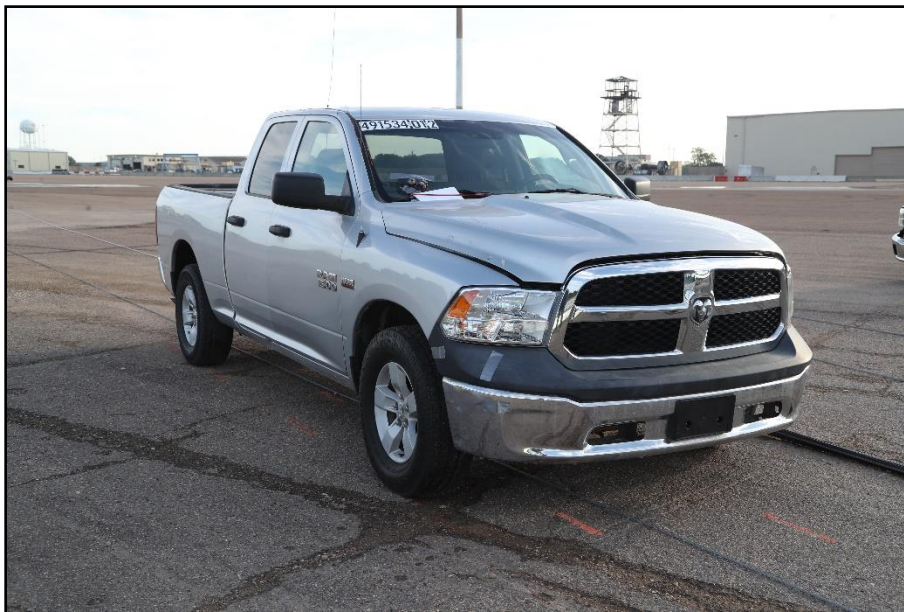
**Figure 6.3. Impact Side of Test Vehicle before Test 491534-01-2.**

Figure 6.3 and Figure 6.4 show the 2018 RAM 1500 used for the crash test. Table 6.4 shows the vehicle measurements. Figure D.1 in Appendix D.1 gives additional dimensions and information on the vehicle.

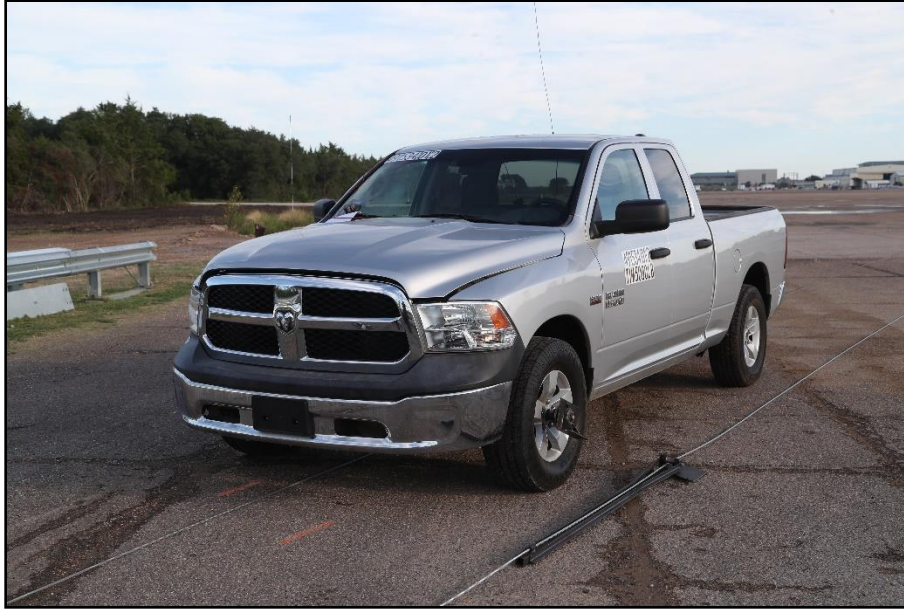
**Figure 6.4. Opposite Impact Side of Test Vehicle before Test 491534-01-2.**

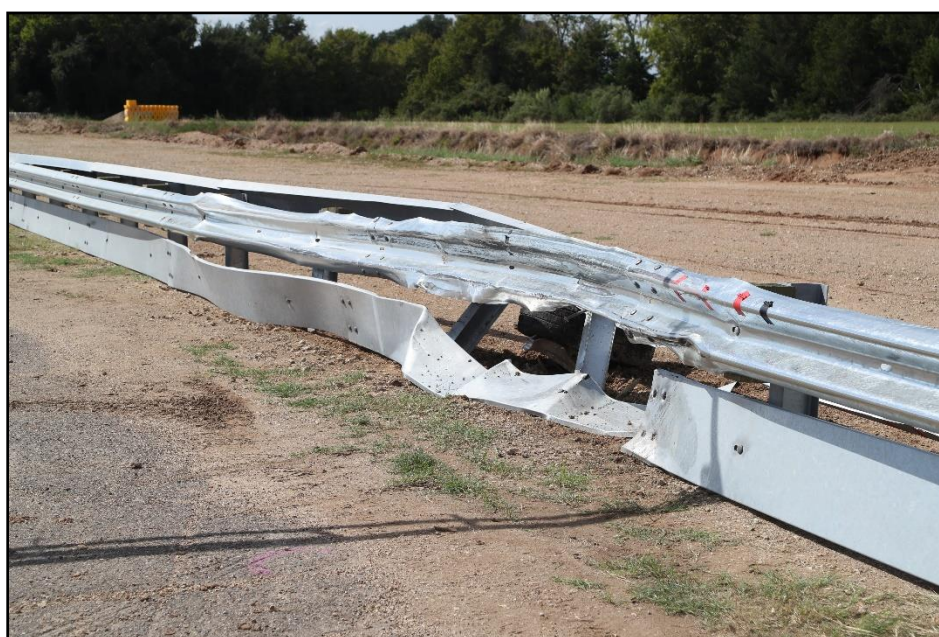
**Figure 6.5. Enhanced Motorcycle MGS at Impact Location after Test 491534-01-2.**

The rail was scuffed and deformed. The cap rail released from posts 5 through 19, and the W-beam was released from posts 13 through 15. The bolt slipped through the joint of the rub rail between posts 12 and 13. The cap rail joint of 12 and 13 had a bolt fail on the field side and an 80 percent pull through on the traffic side. Posts 12 through 14 had severe soil disturbance. Post 15 was twisted counterclockwise.

Table 6.6 describes the damage to the Enhanced Motorcycle MGS. Table 6.7 describes the deflection and working width of the Enhanced Motorcycle MGS. Figure 6.5 and Figure 6.6 show the damage to the Enhanced Motorcycle MGS.

Test Parameter	Measured
Permanent Deflection/Location	18.5 inches toward field side, at post 14
Dynamic Deflection	29.1 inches toward field side, top cover between posts 12 and 13
Working Width <sup>a</sup> and Height	59.9 inches, at a height of 20 inches, on the field side of the top cover at the joint between posts 12 and 13

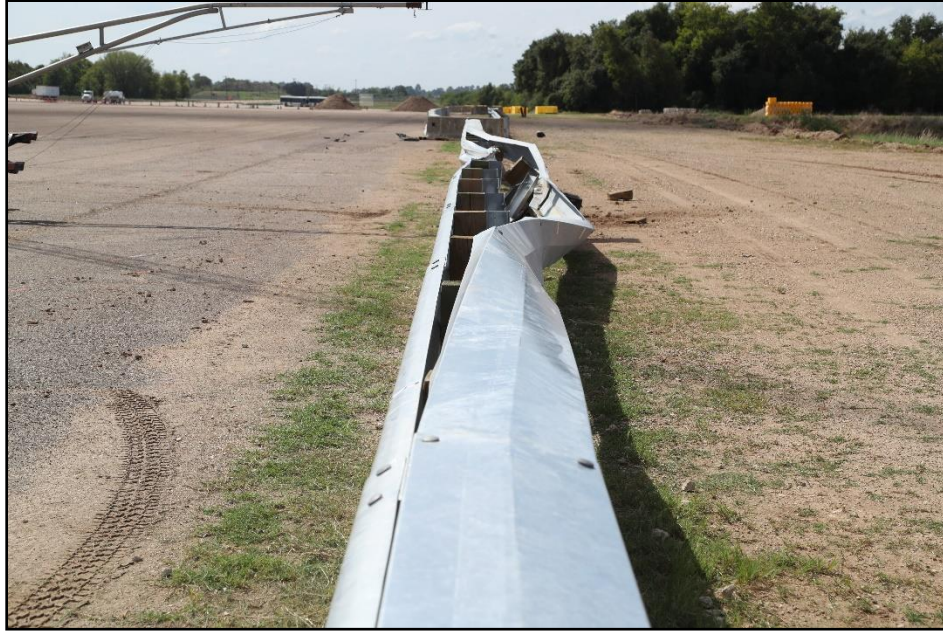
**Figure 6.6. Downstream View of Enhanced Motorcycle MGS after Test 491534-01-2.**

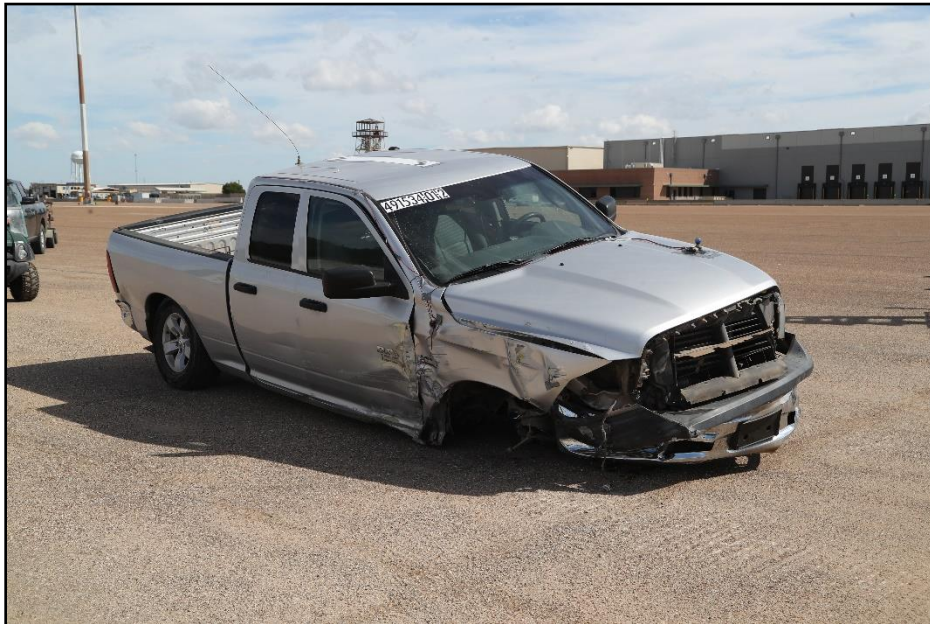
**Figure 6.7. Impact Side of Test Vehicle after Test 491534-01-2.**

Figure 6.7 and Figure 6.8 show the damage sustained by the vehicle. Figure 6.9 and Figure 6.10 show the interior of the test vehicle. Table 6.8 and Table 6.9 provide details on the occupant compartment deformation and exterior vehicle damage. Figures D.2 and D.3 in Appendix D.1 provide exterior crush and occupant compartment measurements.

<b>Side Windows</b>	Side windows remained intact
<b>Maximum Exterior Deformation</b>	12 inches in the front bumper
<b>VDS</b>	01RFQ4
<b>CDC</b>	01FREW5
<b>Fuel Tank Damage</b>	None
<b>Description of Damage to Vehicle:</b>	On the right front, the headlight was gone, the frame was bent, the control arm was ripped off, and the fender and door were dented. The door had a 1-inch gap at the top. The front bumper, grill, and radiator were dented. The right rear door had small dents and scrapes. The right rear quarter fender and rear bumper were dented.

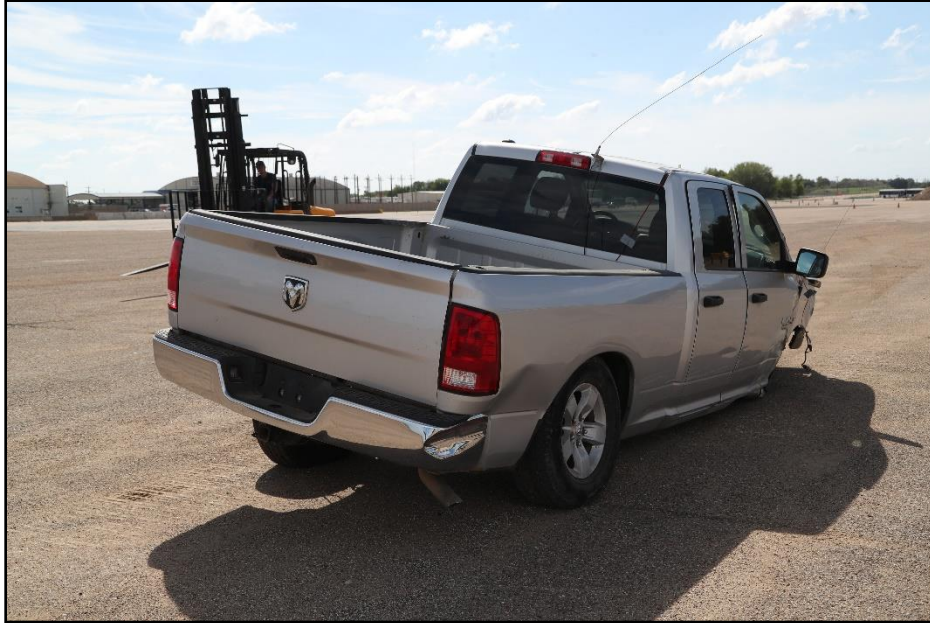
**Figure 6.8. Rear Impact Side of Test Vehicle after Test 491534-01-2.**

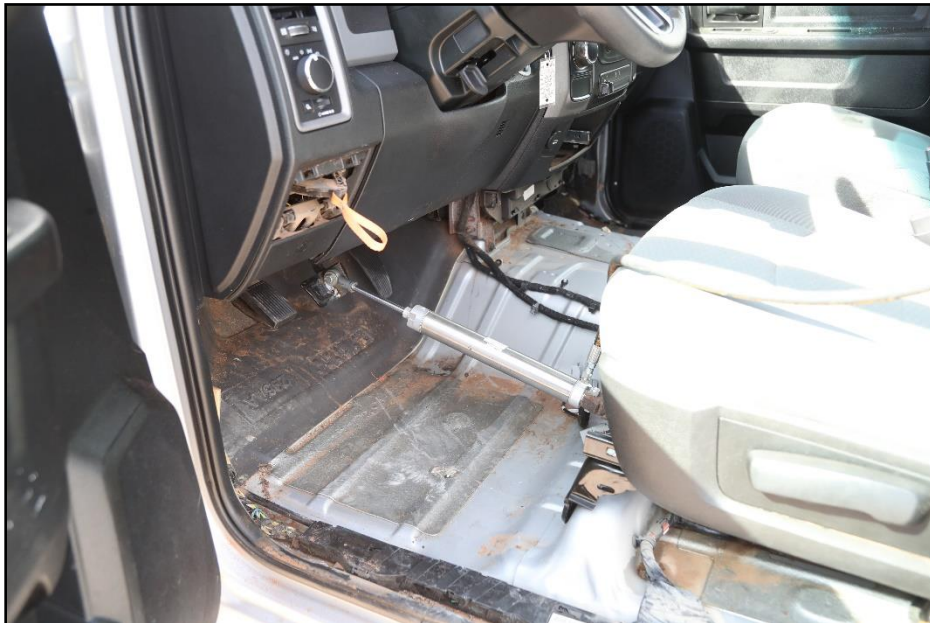
**Figure 6.9. Overall Interior of Test Vehicle after Test 491534-01-2.**

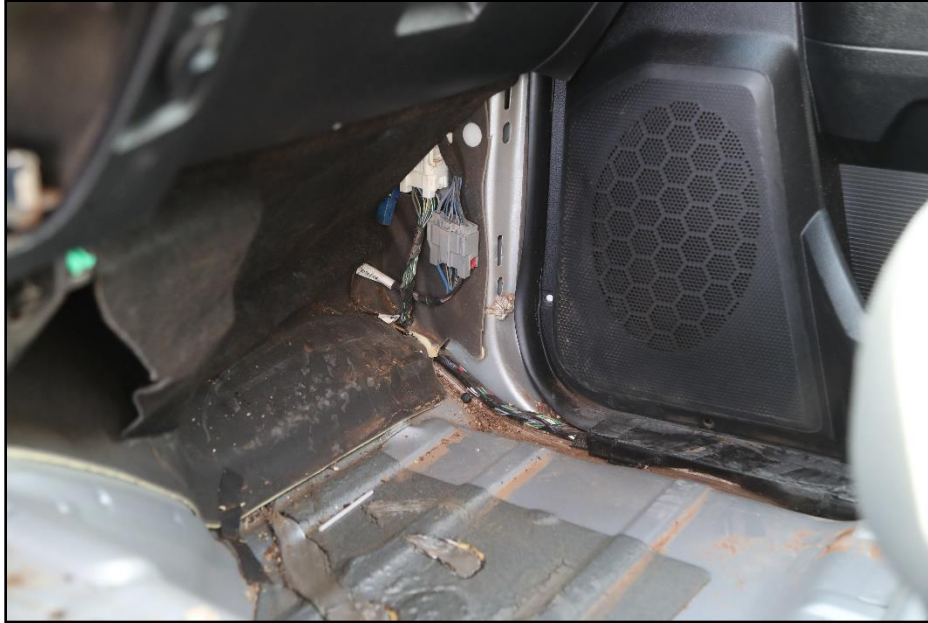
**Figure 6.10. Interior of Test Vehicle on Impact Side after Test 491534-01-2.**

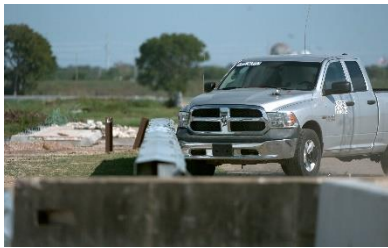
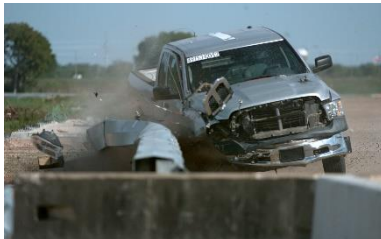
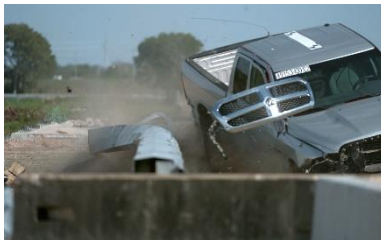
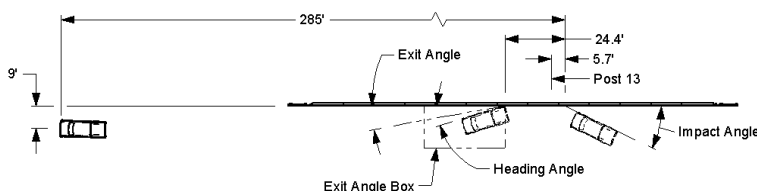
<b>0.000 s</b>	Test Agency		Texas A&M Transportation Institute (TTI)					
	Test Standard/Test No.		MASH 2016, Test 3-11

<b>0.200 s</b>	TTI Project No.		491534-01-2					
	Test Date		2023-10-06

<b>0.400 s</b>	<b>TEST ARTICLE</b>							
	Type		Longitudinal barriers

<b>0.600 s</b>	Name		Enhanced Motorcycle MGS					
	Length		181 ft 3 inches					
	Key Materials		Galvanized steel posts and rails, timber wood blockouts					
	Soil Type and Condition		AASHTO M147-65(2004), Type 1, Grade D crushed concrete					
<b>TEST VEHICLE</b>								
Type/Designation		2270P						
Year, Make and Model		2018 RAM 1500						
Inertial Weight (lb)		5024						
Dummy (lb)		N/A						
Gross Static (lb)		5024						
<b>IMPACT CONDITIONS</b>								
Impact Speed (mi/h)		63.1						
Impact Angle (deg)		25.5						
Impact Location		67.8 inches upstream of centerline of post 13						
Impact Severity (kip-ft)		123.9

<b>EXIT CONDITIONS</b>								
Exit Speed (mi/h)		46.7						
Trajectory/Heading Angle (deg)		9.8/15.7						
Exit Box Criteria		Vehicle met the exit box criteria						
Stopping Distance		285 ft downstream 9 ft to the traffic side						
<b>TEST ARTICLE DEFLECTIONS</b>								
Dynamic (inches)		29.1						
Permanent (inches)		18.5						
Working Width/Height (inches)		59.9/20						
<b>VEHICLE DAMAGE</b>								
VDS		01RFQ4						
CDC		01FREW5						
Max. Ext. Deformation (inches)		12						
Max Occupant Compartment Deformation		No occupant compartment deformation						
<b>OCCUPANT RISK VALUES</b>								
Long. OIV (ft/s)	19.7	Long. Ridedown (g)	7.1	Max 50-ms Long. (g)	-6.7	Max Roll (deg)	11.2	
Lat. OIV (ft/s)	17.4	Lat. Ridedown (g)	7.6	Max 50-ms Lat. (g)	-6.6	Max Pitch (deg)	10.5	
THIV (m/s)	7.8	ASI	0.8	Max 50-ms Vert. (g)	-2.7	Max Yaw (deg)	49.8

**Figure 6.11. Summary of Results for MASH Test 3-11 on Enhanced Motorcycle MGS.**

Figure 6.11 summarizes the results of *MASH* Test 491534-01-2.

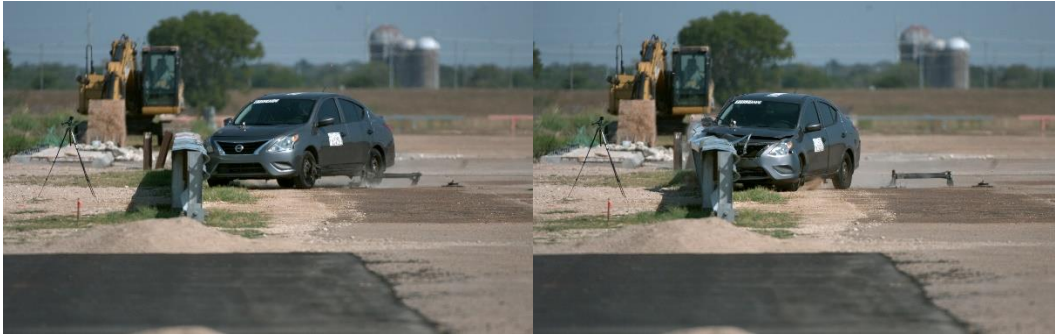
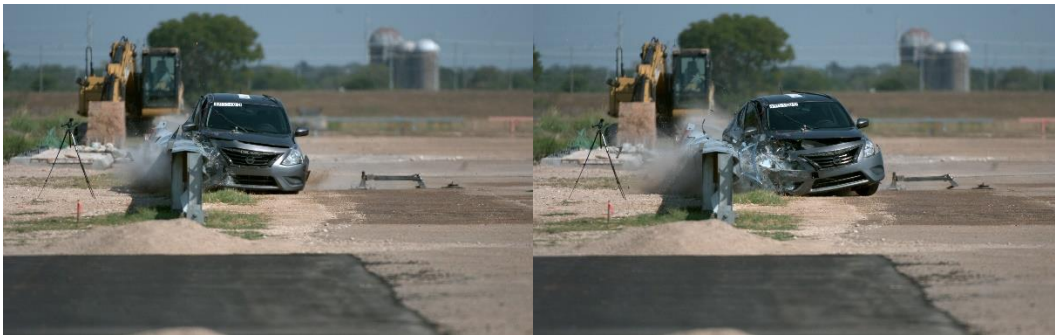
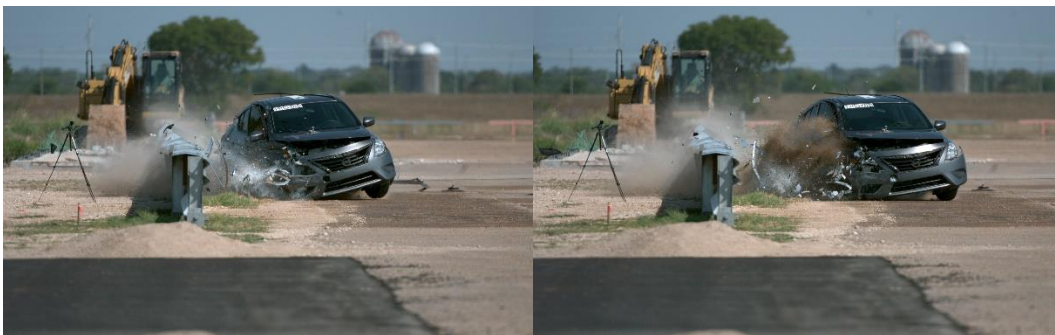
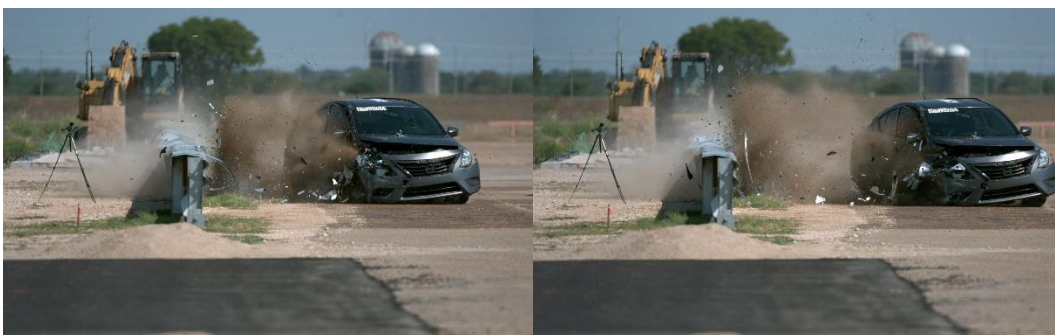
**Figure C.5. Sequential Photographs for Test 491534-01-1 (Frontal Views).**

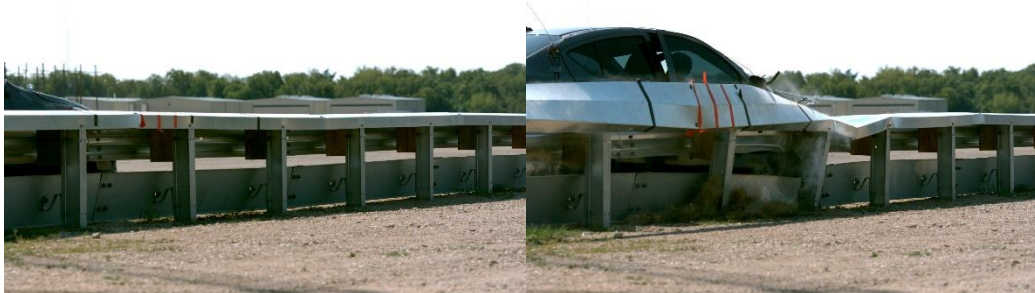
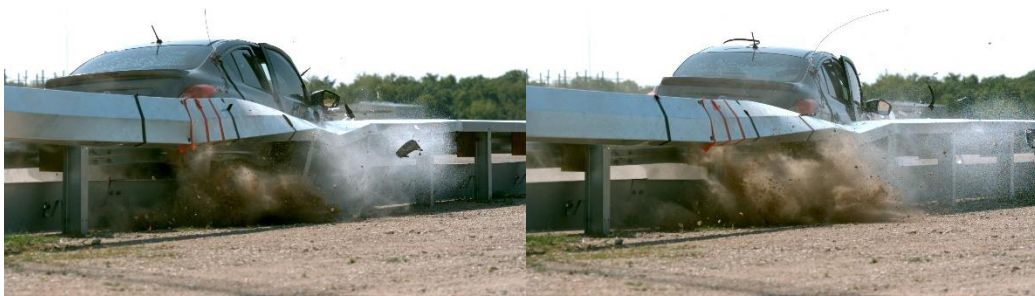
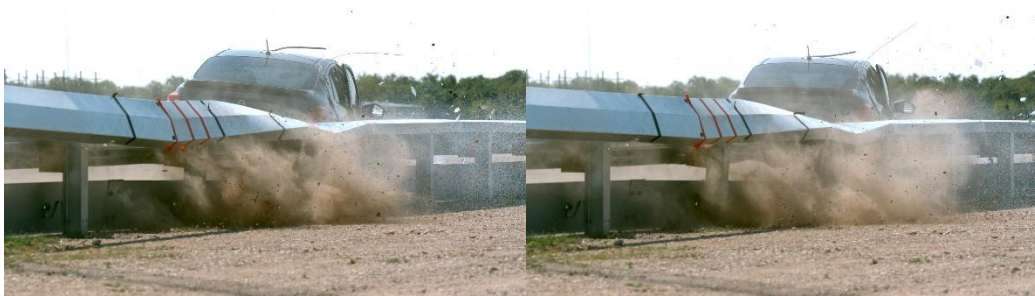
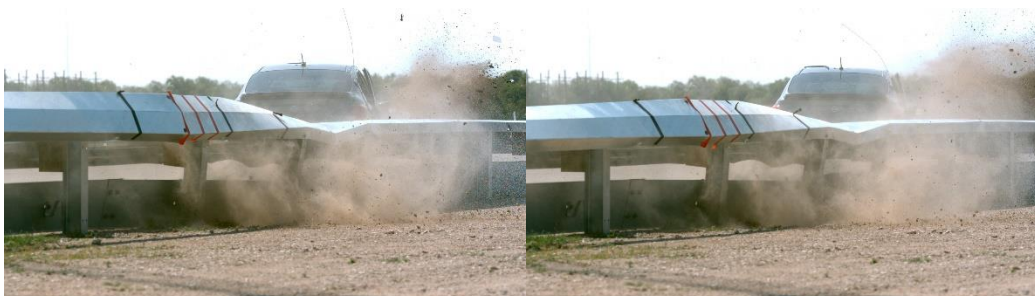
**Figure C.6. Sequential Photographs for Test 491534-01-1 (Rear Views).**
