**Test Report No. 9-1531-R2B**

**EVALUATION OF LOWER AND UPPER RAIL ELEMENTS WITH  
MIDWEST GUARDRAIL SYSTEM TO ADDRESS MOTORCYCLE  
SAFETY**

Sponsored by the  
**Motorcycle Safety Pooled Fund**  
and the  
**Texas Department of Transportation**

**TEXAS A&M TRANSPORTATION INSTITUTE PROVING GROUND**

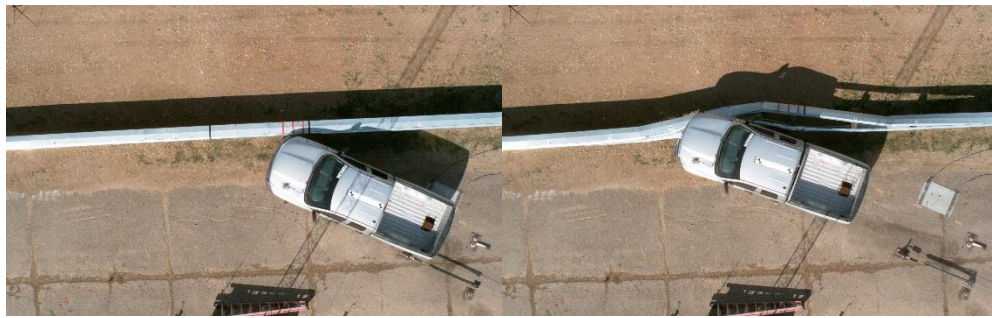
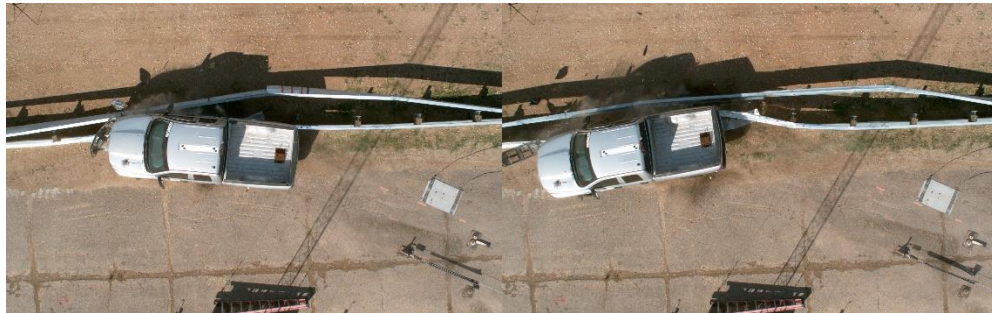
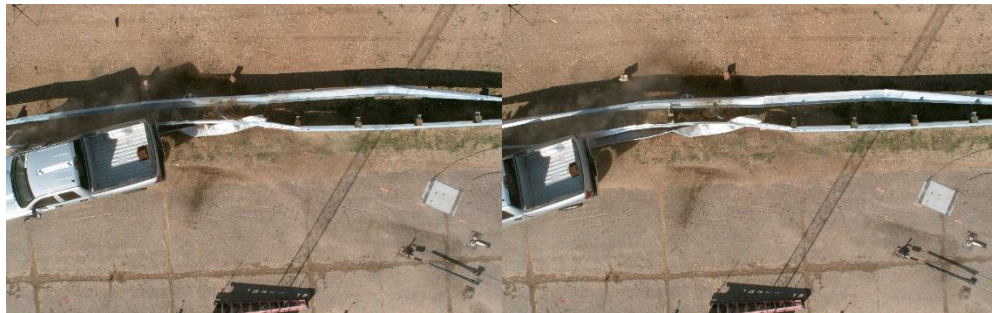
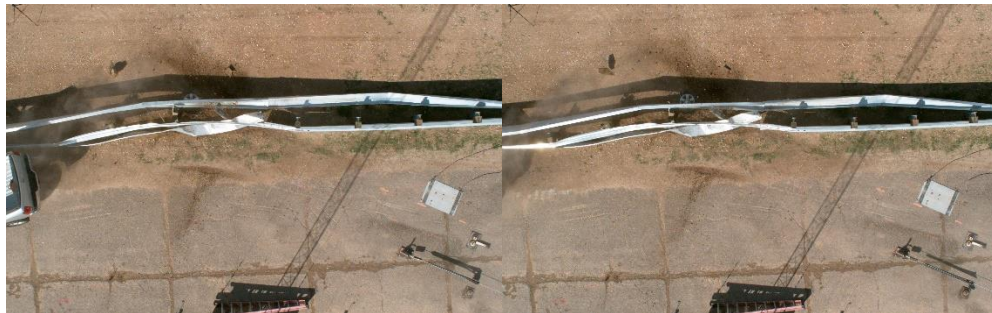
**Figure D.4. Sequential Photographs for Test 491534-01-2 (Overhead Views).**

(a) 0.000 s

(b) 0.100 s

(c) 0.200 s

(d) 0.300 s

(e) 0.400 s

(f) 0.500 s

(g) 0.600 s

(h) 0.700 s

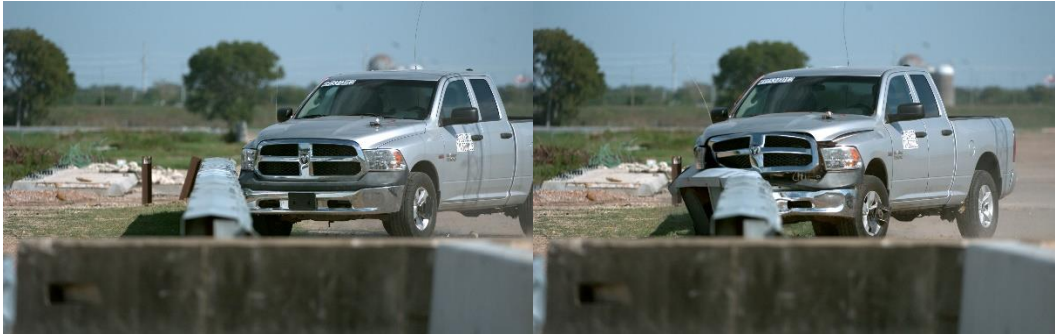
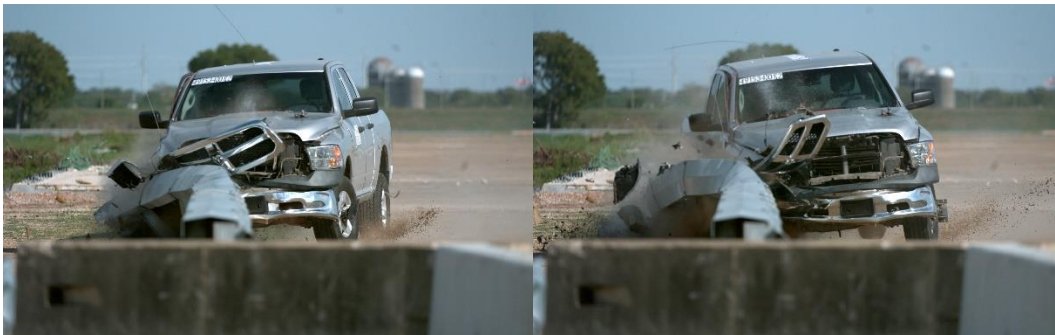
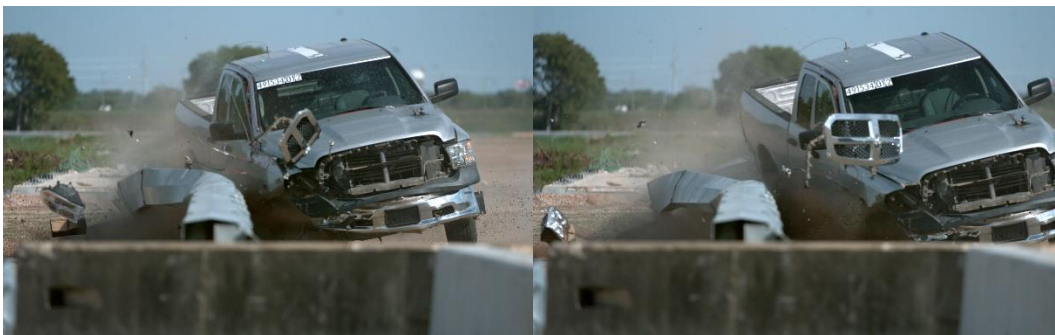
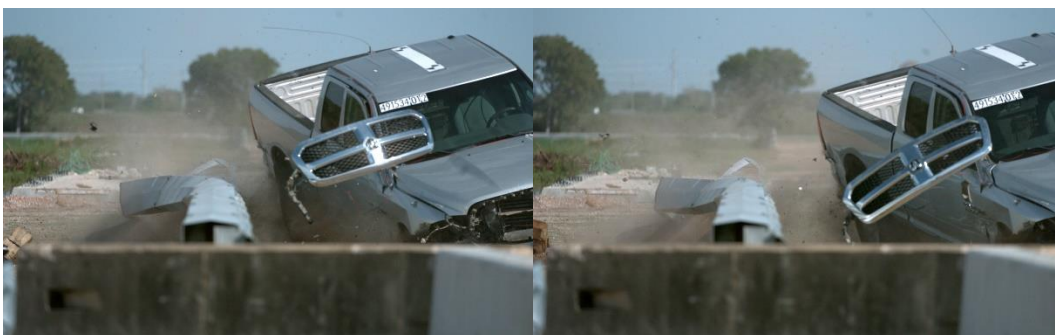
**Figure D.5. Sequential Photographs for Test 491534-01-2 (Frontal Views).**

(a) 0.000 s

(b) 0.100 s

(c) 0.200 s

(d) 0.300 s

(e) 0.400 s

(f) 0.500 s

(g) 0.600 s

(h) 0.700 s

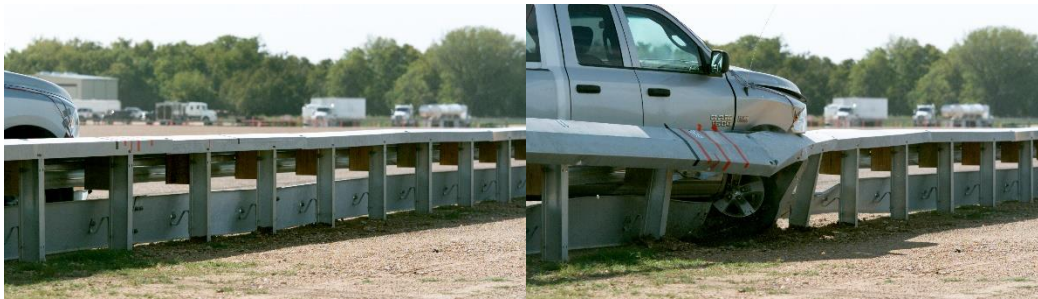
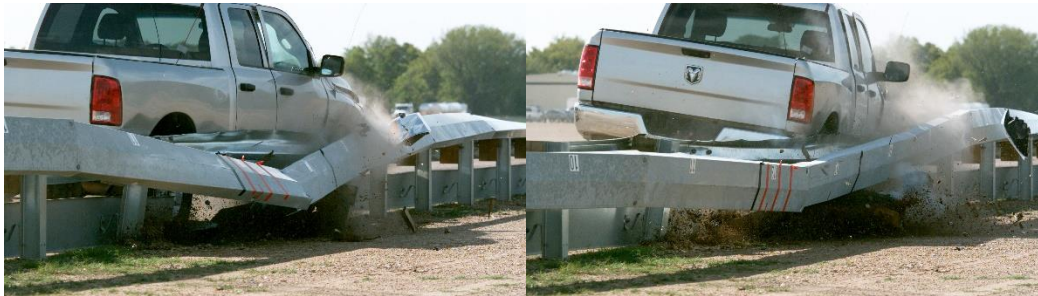
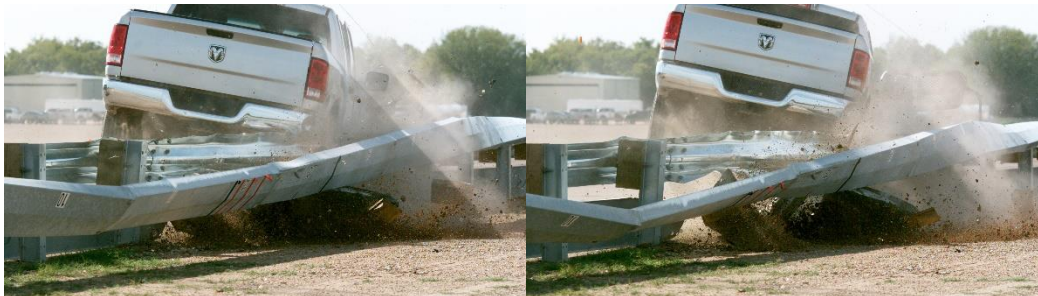
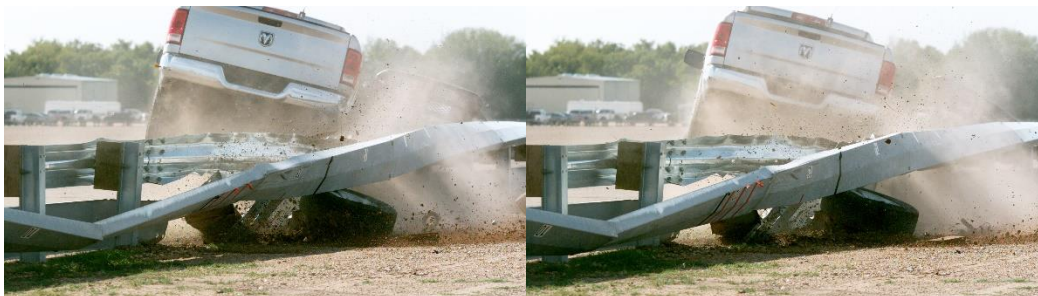
**Figure D.6. Sequential Photographs for Test 491534-01-2 (Rear Views).**

(a) 0.000 s

(b) 0.100 s

(c) 0.200 s

(d) 0.300 s

(e) 0.400 s

(f) 0.500 s

(g) 0.600 s

(h) 0.700 s
